**Flood Control Project Maintenance
Levee Inspections**
LMA District Cover Sheet
Spring 2018 Levee Inspection Results

Yolo County Service Area 6

Spring 2018 Levee Inspection Results

| Waterway | | | Bank | Unit Miles |
|---|---|---|---|---|
| Unit No. 01 Right Bank of Sacramento River at Knights Landing | | | Right | 5.87 |

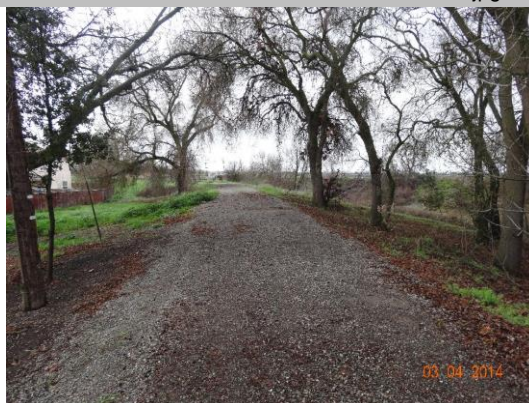
Photo 2 of 3 : UCIP_SP_2018_31903_58221.jpg

Overview of levee crown looking at crossing.

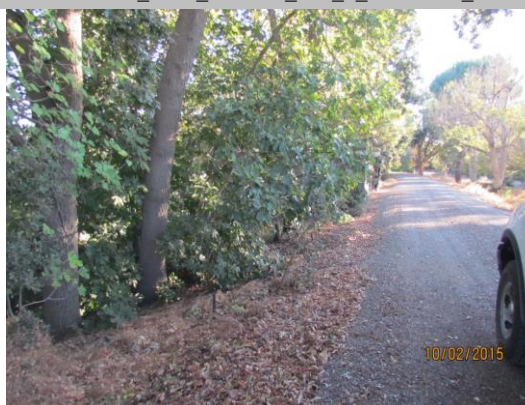
Photo 1 of 1 : SP_2018_NA0022_350_6_20180306_00007.jpg

View of the vegetation and trees on the waterward side of the levee looking downstream. Fall 2015.

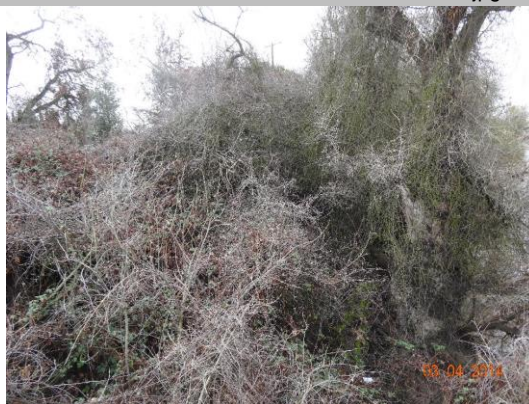
Photo 2 of 3 : UCIP_SP_2018_31904_58227.jpg

View of waterward toe photo taken from bridge.

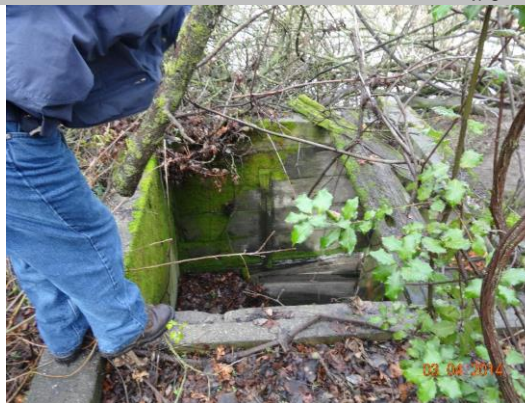
Photo 3 of 3 : UCIP_SP_2018_31904_58226.jpg

| FS_ID:31904 DS_ID:19516 EP_NO: N/A Repair Type: Non-Urgent Crossing Status: Indicator Found UCIP Comments: Need to properly abandon per Title 23 if corssing is no longer used--debris inside concrete box and near site. Need to contact owner. FIELD_STRUCT_DESC: 48-inch corrugated metal gravity drainage pipe through the levee, 14.5 feet below the crown. Slide gate in a concrete box on the waterside (WS) bank. (Automatic Board Order (ABO) issued as Permit No. Unknown, 1976 - Wallace) [Additional Reference(s): DWR Levee Log, 2005]. FS Date: 3/4/2014 | | | | | |

Concrete box located on waterward side.

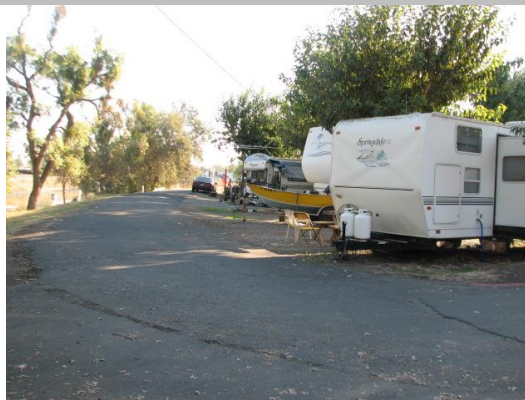
Photo 1 of 2 : SP_2018_NA0022_350_28_20180306_00023.jpg

The RV park is encroached into the levee crown. Fall 2013

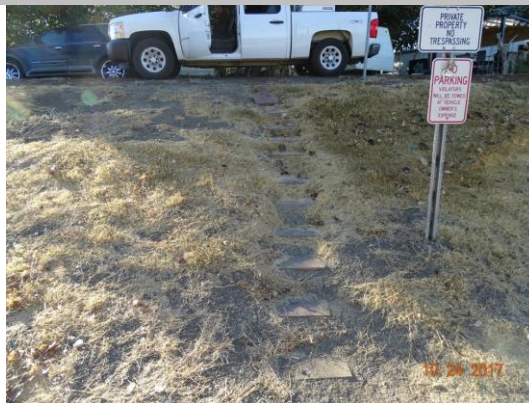
Photo 1 of 1 : SP_2018_NA0022_350_59_20180306_00039.jpg

View of stairs on landside slope. Fall 2017.

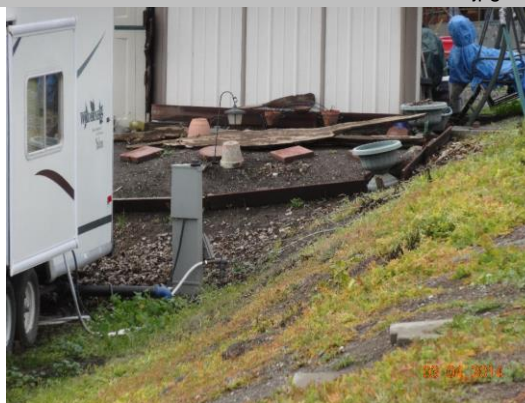
Photo 2 of 3 : UCIP_SP_2018_45403_60804.jpg

Spigot located on landward toe.

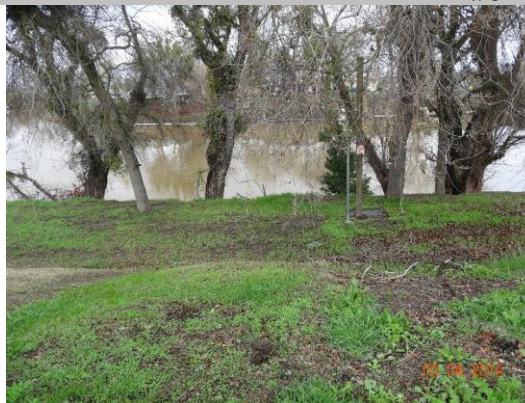
Photo 3 of 3 : UCIP_SP_2018_45403_60803.jpg

| FS_ID:45403 DS_ID:19513 EP_NO: 9424 Repair Type: Non-Urgent Crossing Status: Indicator Found UCIP Comments: Unable to determine alignment of crossing--it's either through levee or along landward side. It appears that the waterline goes along landward side. Need to contact owner to obtain additional information about crossing. 2 inch metal pipe sticking out at the waterward berm edge. FIELD_STRUCT_DESC: Water pipe of an unknown size or material through the levee, at an unknown depth. Faucets on the landside (LS) slope. (Retention of an underground water pipe and faucet on the LS slope authorized under Automatic Board Order (ABO) issued as Permit No. 9424, 1974 - O. H. Ivey). [Additional Reference(s): DWR Levee Log, 2005]. FS Date: 3/4/2014 | | | | | | |

View of waterward side.

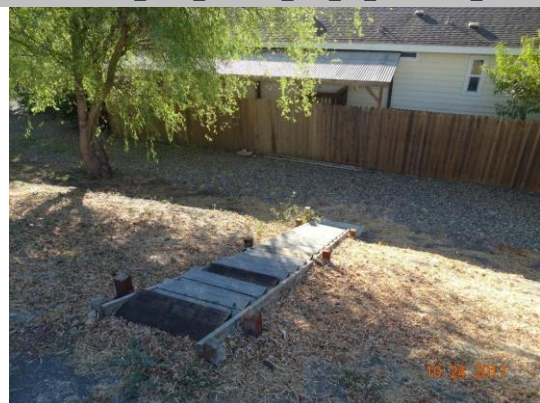
Photo 1 of 1 : SP_2018_NA0022_350_61_20180306_00040.jpg

View of stairs on landside slope. Fall 2017.

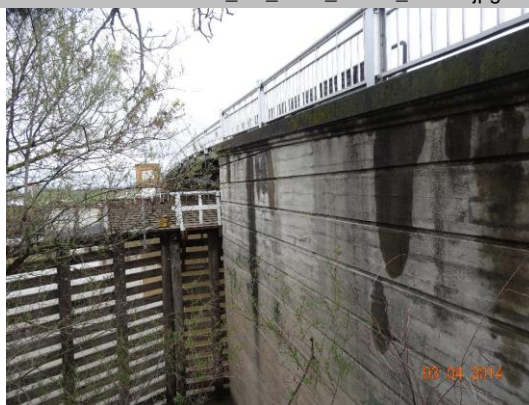
Photo 2 of 2 : UCIP_SP_2018_31906_58237.jpg

No pipe attached along bridge.

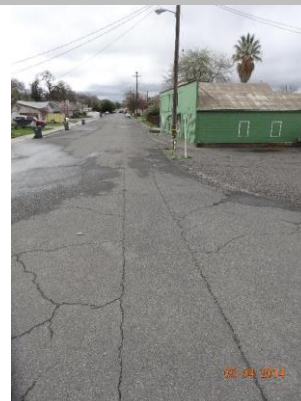
Photo 1 of 3 : UCIP_SP_2018_31627_57881.jpg

| FS_ID:31627 DS_ID:19544 EP_NO: N/A Repair Type: Non-Urgent Crossing Status: Indicator Found UCIP Comments: Unable to confirm if signs of crossing are for the same crossing listed here. Need to contact owner and determine additional information about crossing. Also found is service box for water line--need permit and alignment confirmation. FIELD_STRUCT_DESC: 10-inch steel pipe of an unknown purpose through the levee, at an unknown depth. [Additional Reference(s): DWR Levee Log, 2005. USACE Sacramento O&M Manual 127, June 1953, (Station 285+27)]. FS Date: 3/4/2014 | | | | | |

View of landward side. Alignment is visible on paved road.

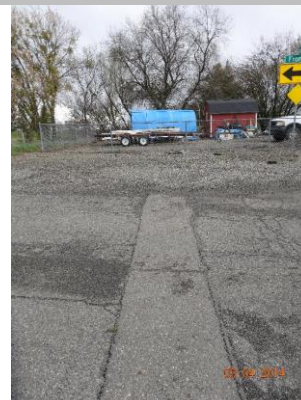
Photo 2 of 3 : UCIP_SP_2018_31627_57880.jpg

View of waterward side. Alignment is visible on paved road.

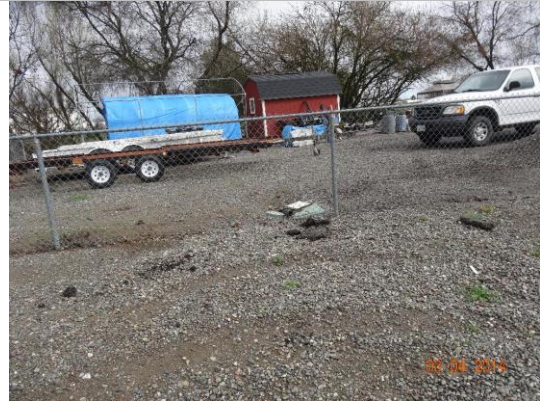
Photo 3 of 3 : UCIP_SP_2018_31627_57879.jpg

| FS_ID:31627 DS_ID:19544 EP_NO: N/A Repair Type: Non-Urgent Crossing Status: Indicator Found UCIP Comments: Unable to confirm if signs of crossing are for the same crossing listed here. Need to contact owner and determine additional information about crossing. Also found is service box for water line--need permit and alignment confirmation. FIELD_STRUCT_DESC: 10-inch steel pipe of an unknown purpose through the levee, at an unknown depth. [Additional Reference(s): DWR Levee Log, 2005. USACE Sacramento O&M Manual 127, June 1953, (Station 285+27)]. FS Date: 3/4/2014 | | | | | |

Service box located on waterward side near fence post.

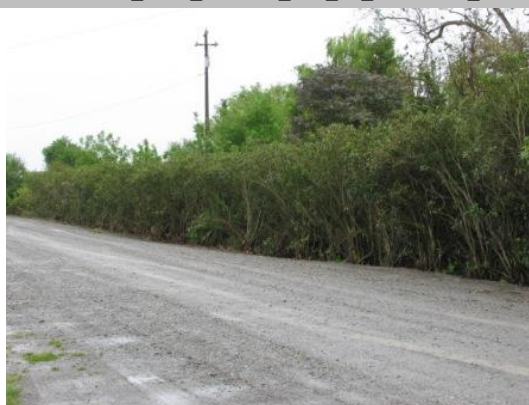
Photo 1 of 1 : SP_2018_NA0022_350_22_20180306_00019.jpg

Oleanders along the shoulder.

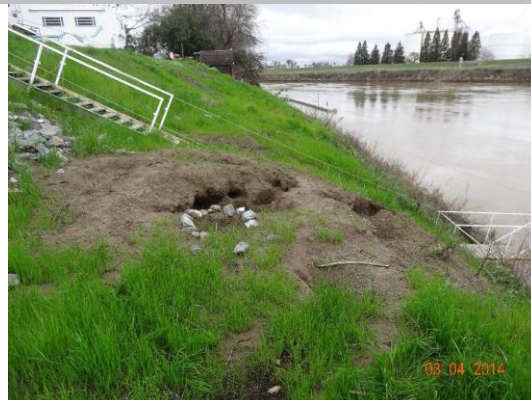
Photo 2 of 3 : UCIP_SP_2018_38188_69560.jpg

View of waterward slope. Large hole visible on waterward side.

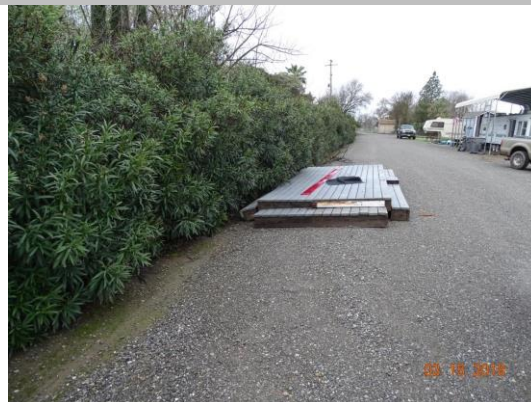
Photo 1 of 1 : SP_2018_NA0022_350_64_20180315_00142.jpg

View of deck on the crown. Spring 2018.

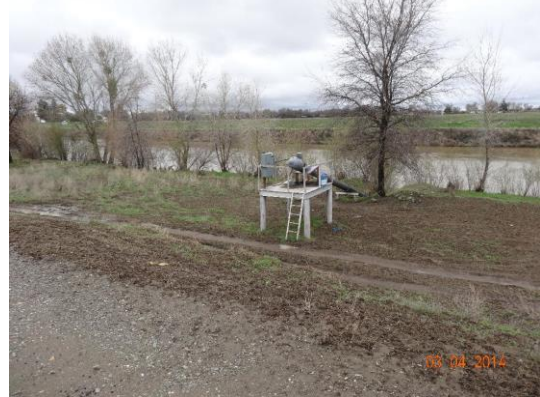
Photo 1 of 3 : UCIP_SP_2018_31969_58410.jpg

| FS_ID:31969 DS_ID:19540 EP_NO: N/A Repair Type: Non-Urgent Crossing Status: Found UCIP Comments: Pipe section on waterward side appears to have been removed and reinstalled--Need to contact owner to obtain additional information regarding work completed. FIELD_STRUCT_DESC: 14-inch steel irrigation discharge pipe through the levee, 4.6 feet below the crown. Pump and valve on the riverbank. See DS_ID 19521. (Plans for installation of an angle mount low-lift pump and structure to replace an existing portable pumping plant, which will be connected to the existing 14-inch discharge pipe through the levee authorized under Permit No. 3798, 1961 - Alta Morris). [Additional Reference(s): USACE Sacramento O&M Manual 127, June 1953, (Station 266+72.2)]. FS Date: 3/4/2014 | | | | | |

View of waterward side.

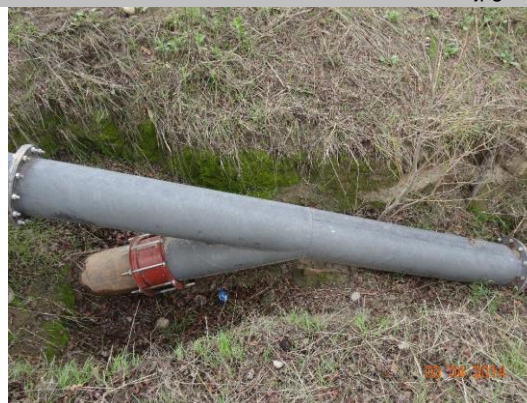
Photo 3 of 3 : UCIP_SP_2018_31969_58408.jpg

| FIELD_STRUCT_DESC: 14-inch steel irrigation discharge pipe through the levee, 4.6 feet below the crown. Pump and valve on the riverbank. See DS_ID 19521. (Plans for installation of an angle mount low-lift pump and structure to replace an existing portable pumping plant, which will be connected to the existing 14-inch discharge pipe through the levee authorized under Permit No. 3798, 1961 - Alta Morris). | | | | | | |

Pipe junction exposed on waterward side.

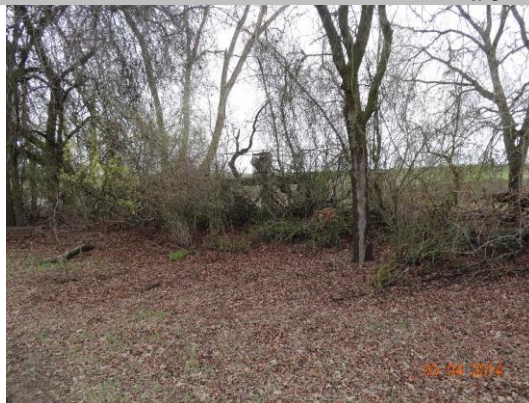
Photo 3 of 3 : UCIP_SP_2018_31912_58259.jpg

| FS_ID:31912 DS_ID:19522 EP_NO: 6296 Repair Type: Non-Urgent Crossing Status: Found UCIP Comments: Siphon breaker housing on landward slope unit damaged and debris scattered on landward side. Unable to determine if crossing is still in use. Need to contact owner to determine status of crossing. FIELD_STRUCT_DESC: 12-inch (not 14-inch as indicated in the desk study) coated steel irrigation discharge pipe through the levee, 11.8 feet below the crown. Standard corrugated metal cutoff wall around pipe at centerline of levee. 1.25-inch electrical conduit through the levee. Electrical control panel on the waterside (WS) slope. Slant pump mounted on a steel structure on the riverbank. Siphon breaker on the landside (LS) shoulder. Pipe extends from pump to existing irrigation ditch at the LS toe. (Plans to install a pump and pipe through the levee authorized under Permit No. 6296, 1968 - Emma Collier). [Additional Reference(s): DWR Levee Log, 2005]. FS Date: 3/4/2014 | | | | | | |

View of waterward side.

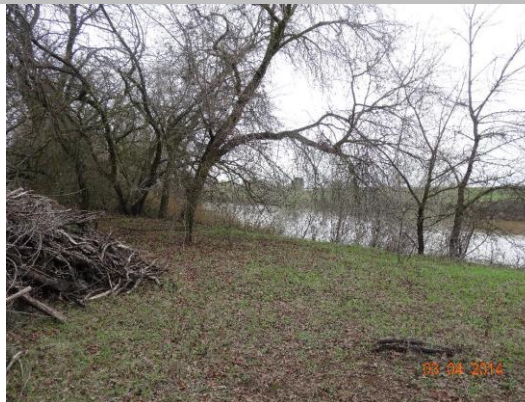
Photo 2 of 3 : UCIP_SP_2018_38190_69565.jpg

| FIELD_STRUCT_DESC: *ABANDONED* 12-inch corrugated metal irrigation discharge pipe through the levee, at an unknown depth. Gate valve in pump house on the waterside (WS), no pump house found. | | | | | | |

View of waterward side.

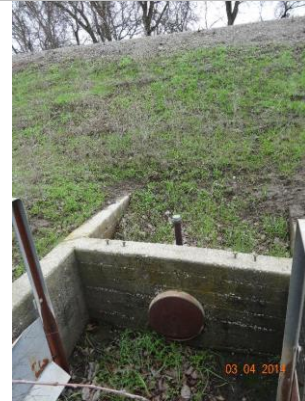
Photo 3 of 3 : UCIP_SP_2018_38190_69564.jpg

Concrete box located on landward toe.

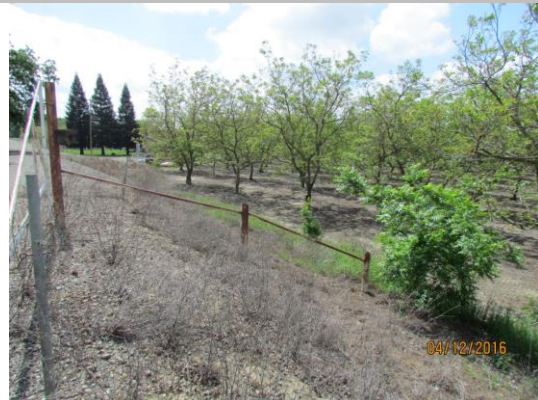
Photo 1 of 1 : SP_2018_NA0022_350_112_20180306_00066.jpg

View of the tree at the toe of the levee on the landward side looking downstream. Spring 2016.

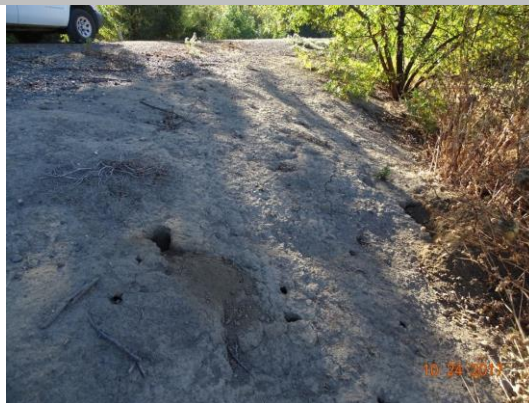
Photo 1 of 2 : SP_2018_NA0022_350_119_20180306_00069.jpg

Updated view of rodent holes on landside slope. Fall 2017.

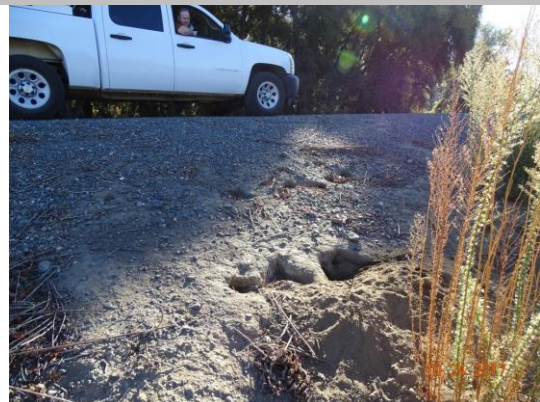
Photo 1 of 2 : SP_2018_NA0022_350_117_20180306_00067.jpg

View of rodent holes on landside slope. Fall 2017.

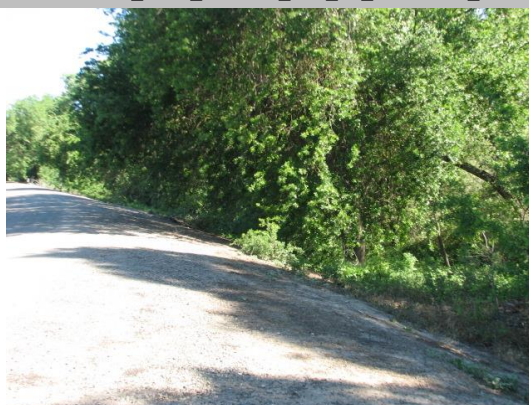
Photo 1 of 1 : SP_2018_NA0022_350_19_20180306_00017.jpg

Trees and brush obstruct visibility on the berm area. Spring 2014

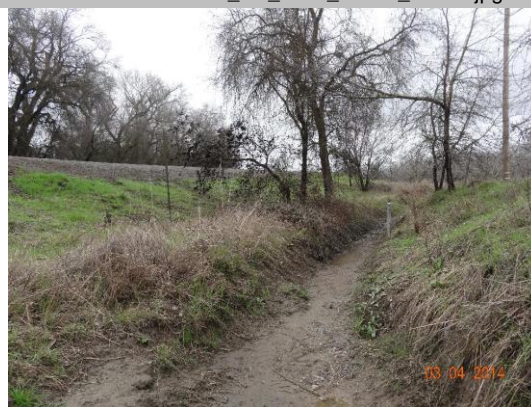
Photo 2 of 3 : UCIP_SP_2018_31915_58269.jpg

View of canal runs parallel on landward toe.

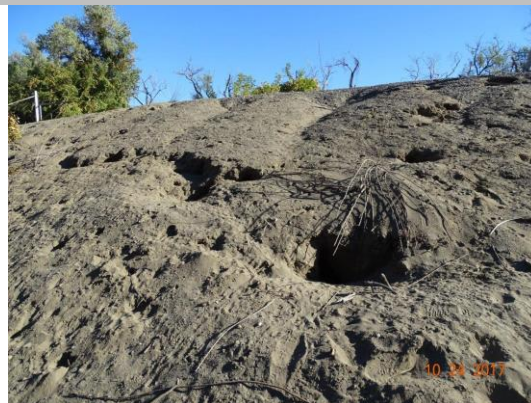
Photo 2 of 2 : SP_2018_NA0022_350_8_20180306_00009.jpg

View of rodent holes on landside slope. Fall 2017.

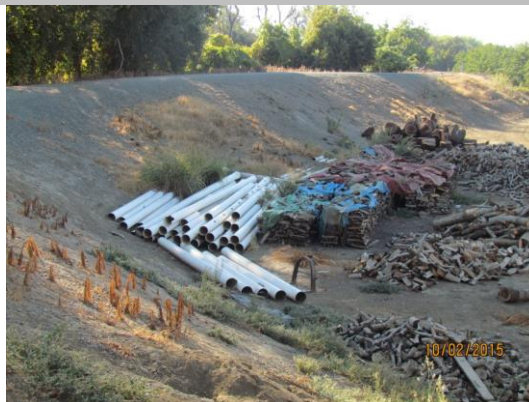
Photo 2 of 2 : SP_2018_NA0022_350_40_20180306_00032.jpg

View of equipment on the landward side of the levee looking downstream. Fall 2015.

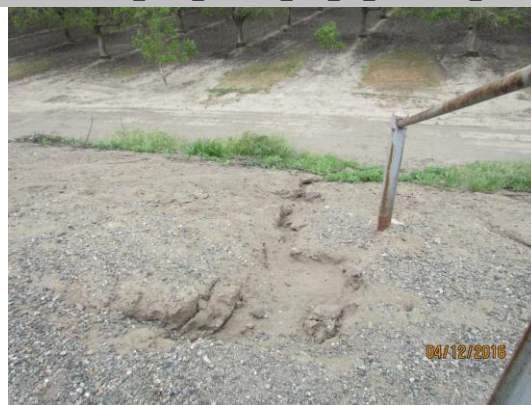
Photo 1 of 2 : SP_2018_NA0022_350_35_20180306_00025.jpg

Erosion is on the landward side of the levee. Spring 2016.

| E2 : Schedule repair of erosion site prior to the next inspection. | | | | | |

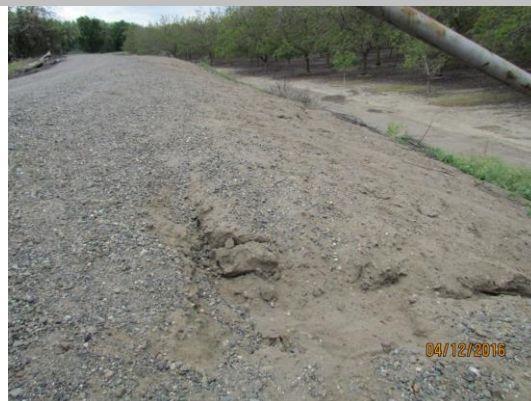
Photo 2 of 2 : SP_2018_NA0022_350_35_20180306_00026.jpg

Perspective view of the erosion on the landward side of the levee. Spring 2016.

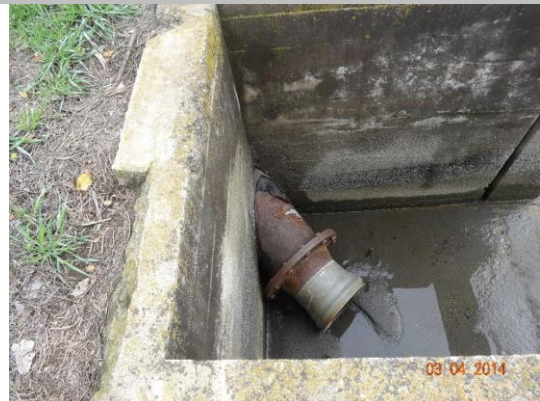
Photo 3 of 3 : UCIP_SP_2018_49982_57913.jpg

Outlet located on LS.

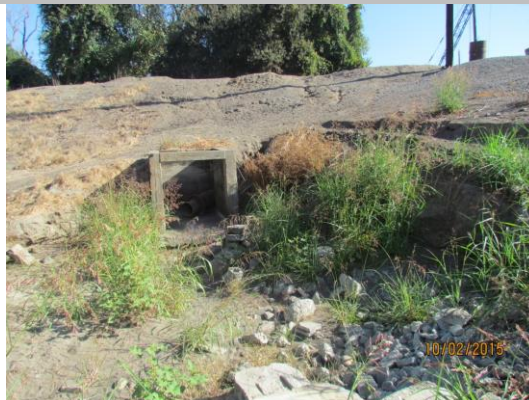
Photo 3 of 4 : SP_2018_NA0022_350_96_20180306_00062.jpg

The erosion is within the levee prism. Fall 2015.

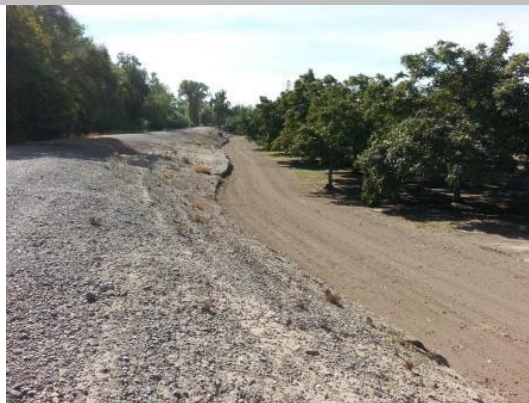
Photo 1 of 2 : SP_2018_NA0022_350_94_20180306_00058.jpg

An updated view of the site where landside slope was tilled due to agricultural activity. Fall inspection 10/07/2016.

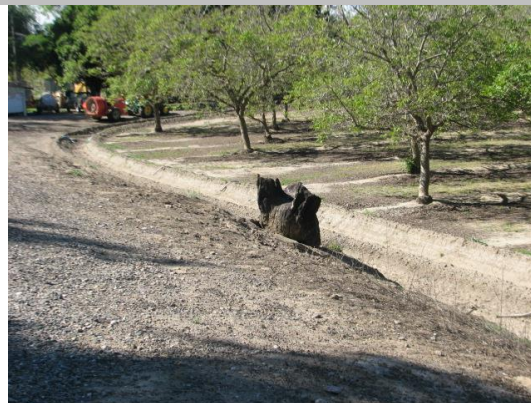
Photo 1 of 1 : SP_2018_NA0022_350_37_20180306_00029.jpg

Tree stump decomposing and may pose a risk to the levee. Spring 2014

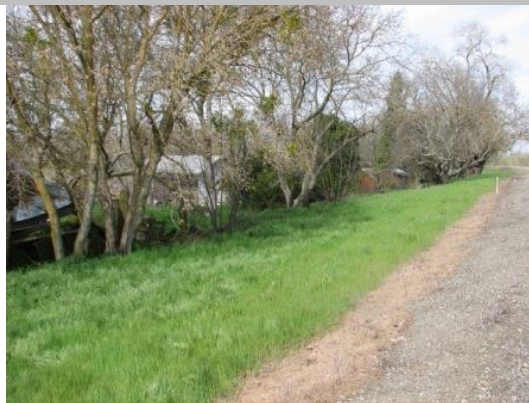
Photo 2 of 2 : SP_2018_NA0022_350_12_20180306_00015.jpg

The buildings are encroaching into the levee slope.

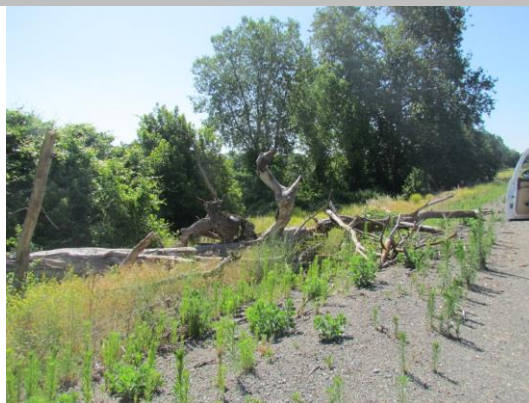
Photo 2 of 2 : SP_2018_NA0022_350_47_20180306_00035.jpg

View of the fallen tree on the waterward side of the levee looking downstream. Spring 2015.

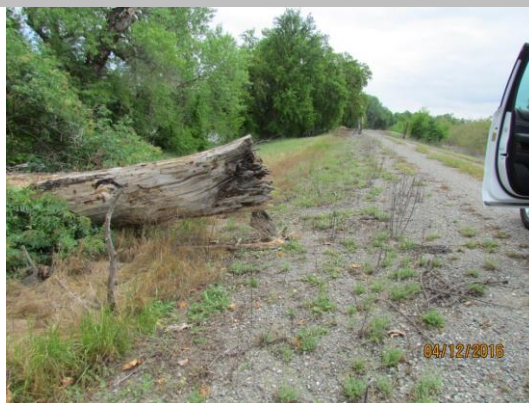
Photo 1 of 1 : SP_2018_NA0022_350_15_20180306_00016.jpg

View of the fallen tree on the waterward slope of the levee looking downstream. Spring 2016.

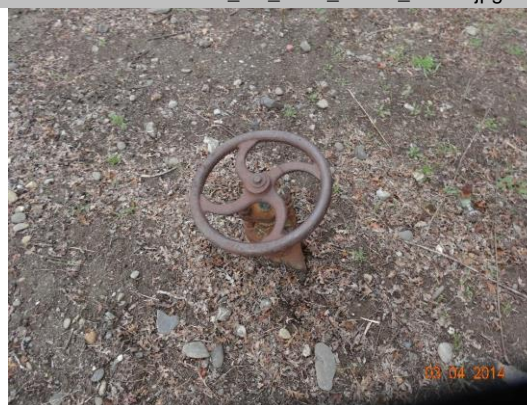
Photo 2 of 3 : UCIP_SP_2018_39858_71840.jpg

Positive closure device is buried on waterward side.

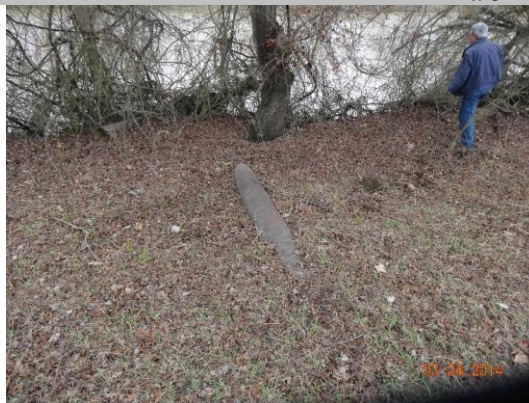
Photo 3 of 3 : UCIP_SP_2018_39858_71845.jpg

Pipe section visible on waterward side.

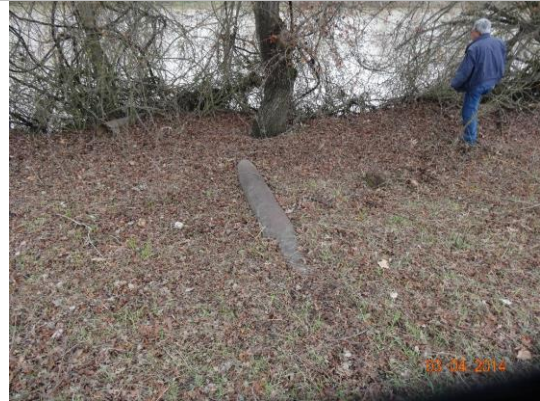
Photo 3 of 3 : UCIP_SP_2018_31916_58273.jpg

Pipe section visible on waterward side.

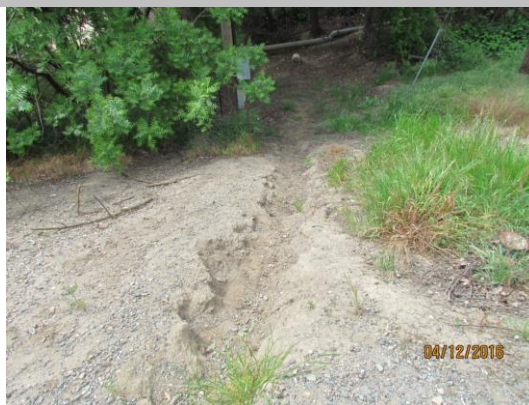
Photo 2 of 3 : SP_2018_NA0022_350_79_20180306_00047.jpg

Dirt stairs has eroded and caused a slope stability. Spring 2016.

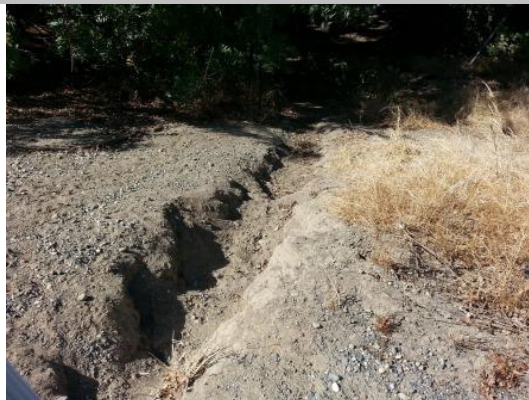
Photo 3 of 3 : SP_2018_NA0022_350_79_20180306_00048.jpg

Stairwell has eroded more creating erosion issue. Fall inspection 10/07/2016.

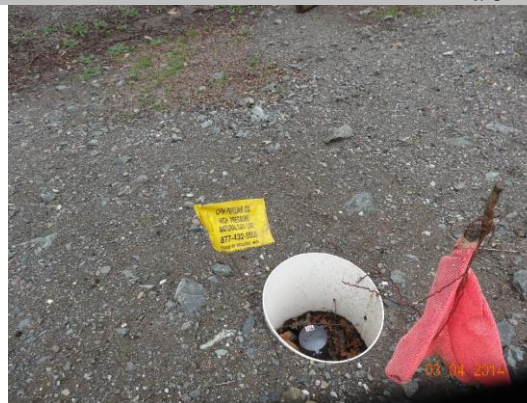
Photo 3 of 3 : UCIP_SP_2018_52542_58281.jpg

Flow meter located on waterward shoulder.

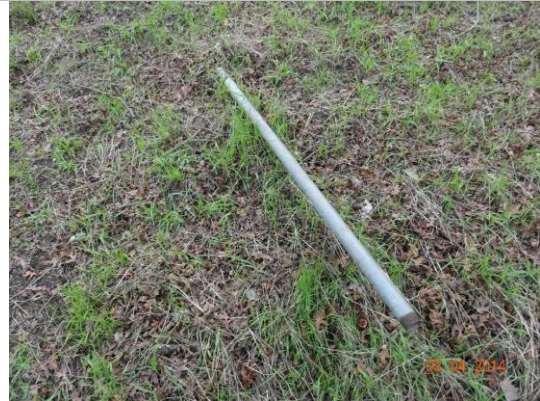
Photo 3 of 3 : UCIP_SP_2018_38996_69566.jpg

Abandoned conduit line through levee.

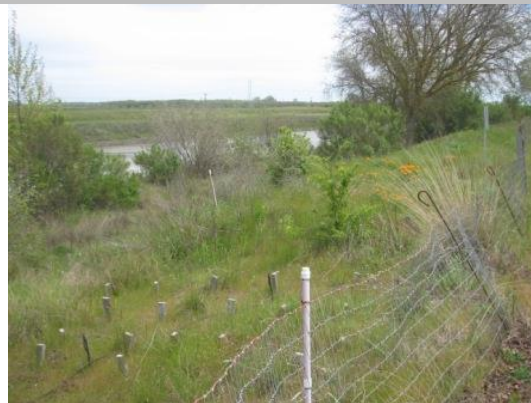
Photo 2 of 2 : SP_2018_NA0022_350_36_20180306_00028.jpg

Fence, irrigation and stakes in the revegetation site.

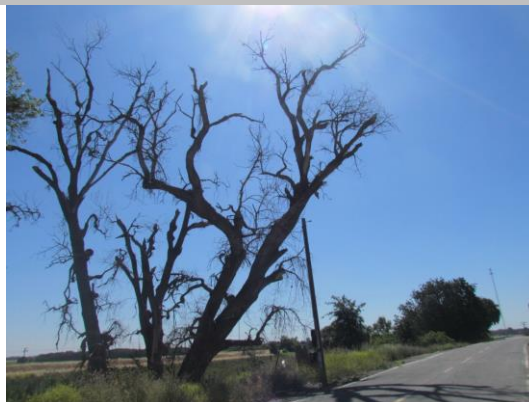
Photo 1 of 1 : SP_2018_NA0022_350_81_20180306_00049.jpg

View of the dying tree on the waterward side of the levee looking downstream. Spring 2015.

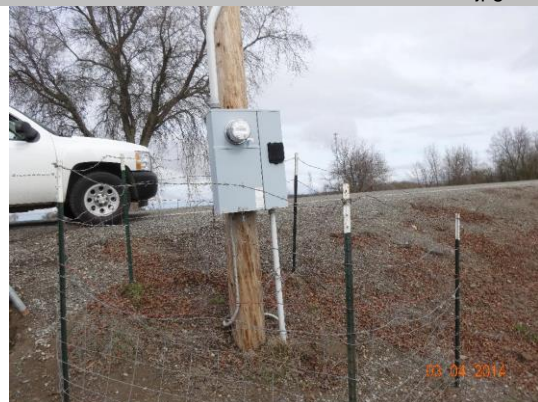
Photo 2 of 3 : UCIP_SP_2018_49983_69572.jpg

Power pole with conduit line through levee.

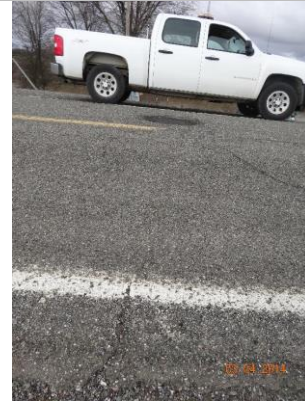
Photo 3 of 3 : UCIP_SP_2018_52543_58456.jpg

View of levee crown. Signs of sink hole repair along pipe alignment.

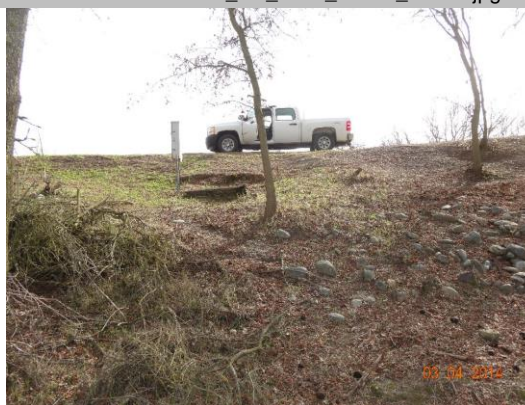
Photo 2 of 3 : UCIP_SP_2018_31927_58331.jpg

Rip rap along waterward slope.

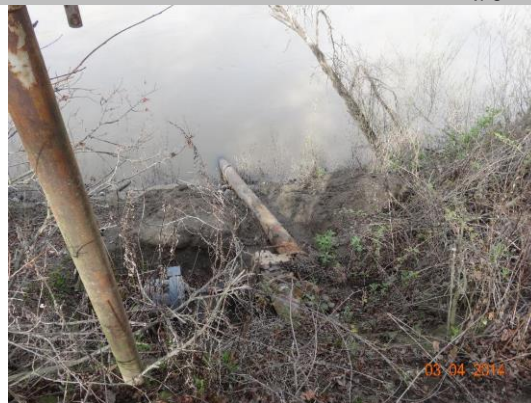
Photo 3 of 3 : UCIP_SP_2018_31927_58335.jpg

Pipe visible on waterward toe.

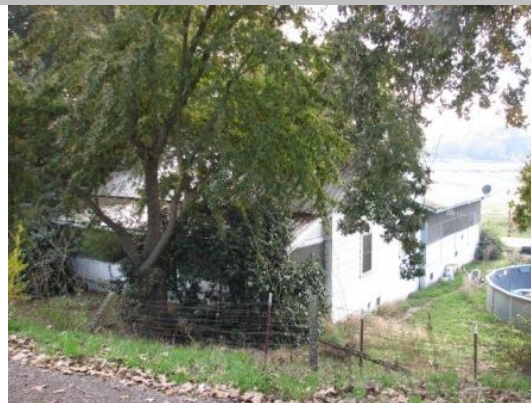
Photo 1 of 1 : SP_2018_NA0022_350_1_20180306_00001.jpg

The house and landscape are in the easment of the levee. Fall 2011
